New methodology for assessment of reinforced concrete structures with non-destructive testing

L. Ebensperger ^{1*}, J. P. Donoso ^{**}

* Construtechnik Ltda. – Santiago, CHILE

** BDL Soluciones Estructurales SpA – Santiago, CHILE

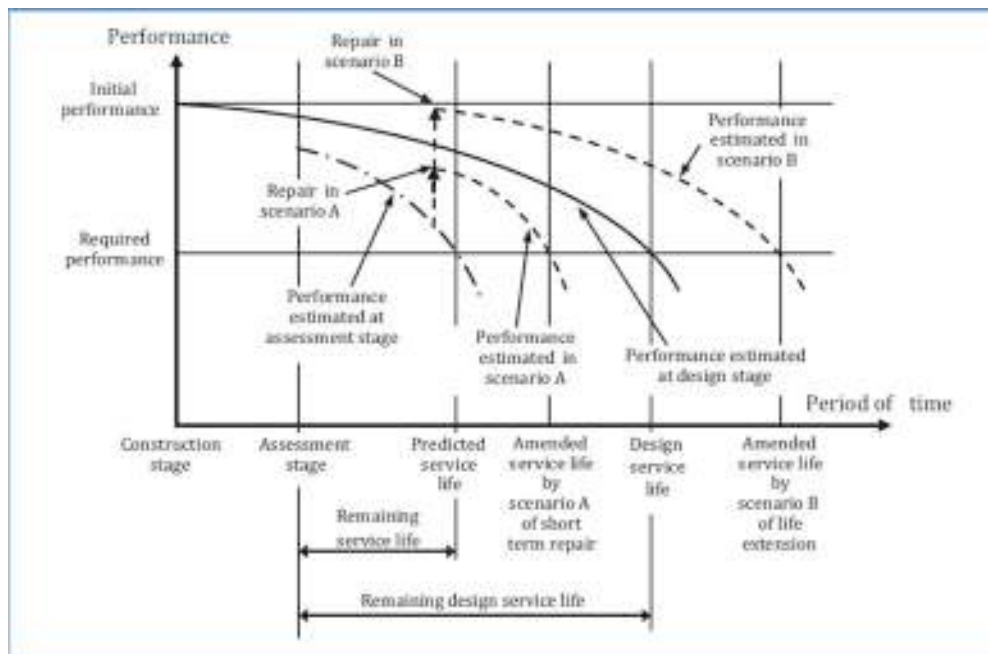
Figure 1. Level of Serviceability of a structure over time (adapted from ISO 16311, 2014)

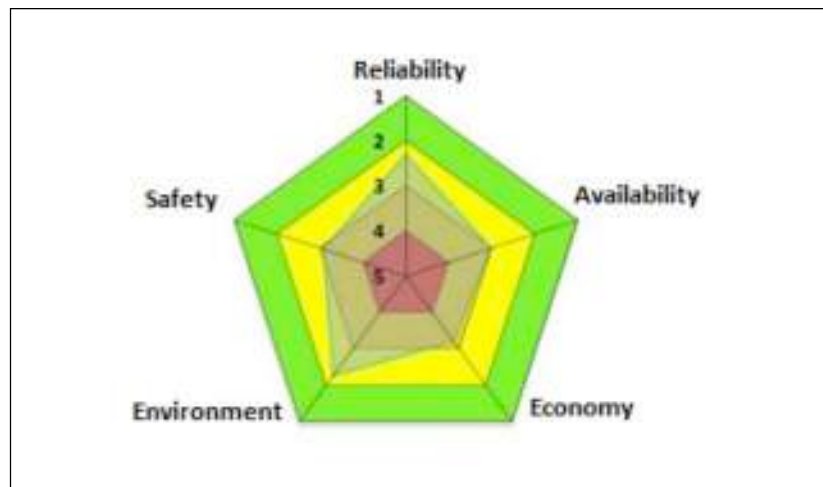
The multi-criteria analysis proposed in the Methodology provides Key Performance Indicators (KPIs), which are displayed in a "spider" chart (see Figure 4), where scale 1 represents the most favorable situation and scale 5 the least favorable. The defined classification is detailed as follows:

Figure 4. Chart representing the results obtained through the use of KPIs

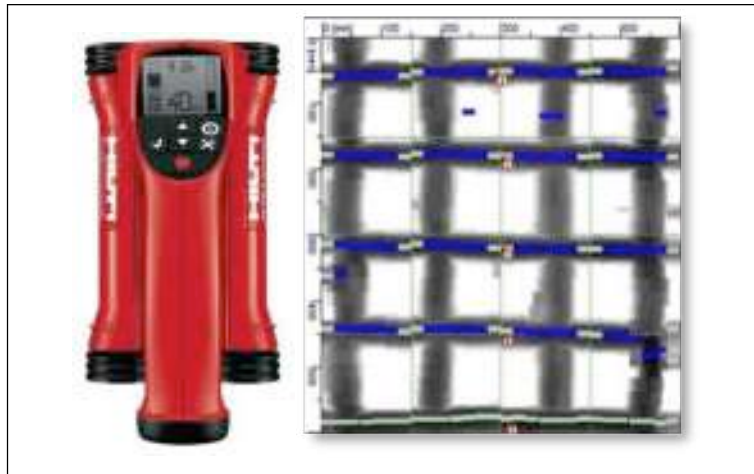
Inspection equipment based on magnetic pulses that provides immediate information on the location of reinforcing bars inserted in the concrete, allowing the detection of diameter, spacing and depth (cover thickness). (Figure 5)

Figure 5. FerroScan PS200 Equipment - Reinforcement location

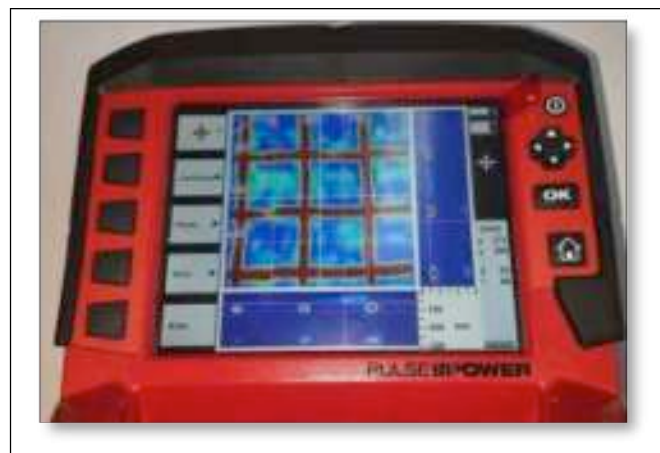
Inspection equipment or scanner that has the latest portable Ground Penetration Radar (GPR) technology. It also detects nests, holes and cavities that are not visible to the naked eye and that are hidden inside structural elements (Figure 6)

Figure 6. FerroScan PS1000 Equipment - Reinforcement Information

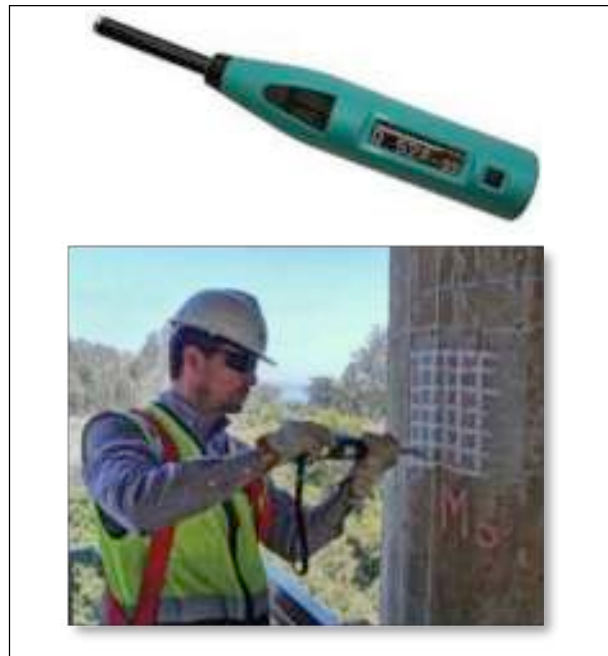
The Schmidt Sclerometer or Schmidt Hammer approximately estimates compressive strength through correlation with calibrated tables. It is based on the resistance measured when giving a blow and recording the rebound. Values must be corrected in case of carbonation. (Figure 7)

Figure 7. Schmidt Hammer - Concrete Strength

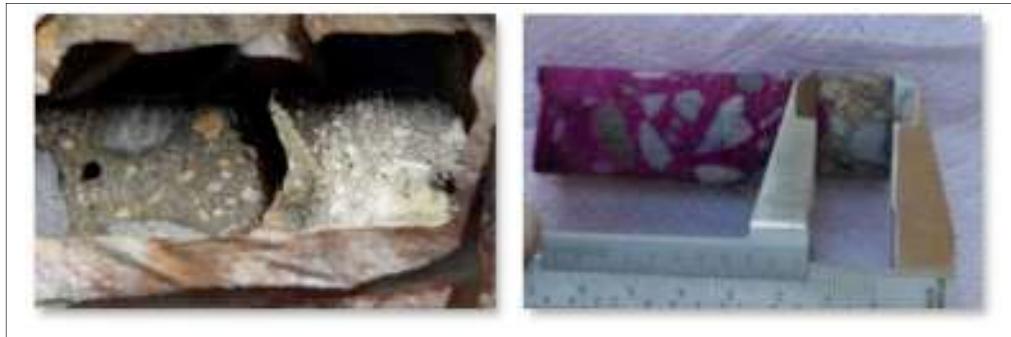
Through the extraction of 1" cores, which are sprayed with a phenolphthalein solution or a silver nitrate solution at the time of extraction. (Figure 9)

Figure 9. Carbonation Depth and Chloride Penetration

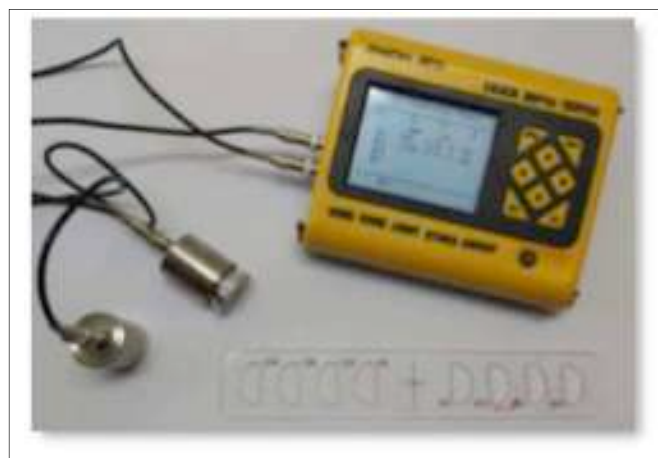
The ultrasonic equipment allows in a simple way to estimate the depth when a crack is detected in the concrete. It requires a previous calibration on a nearby surface without cracks. (Figure 10)

Figure 10. Crack Depth

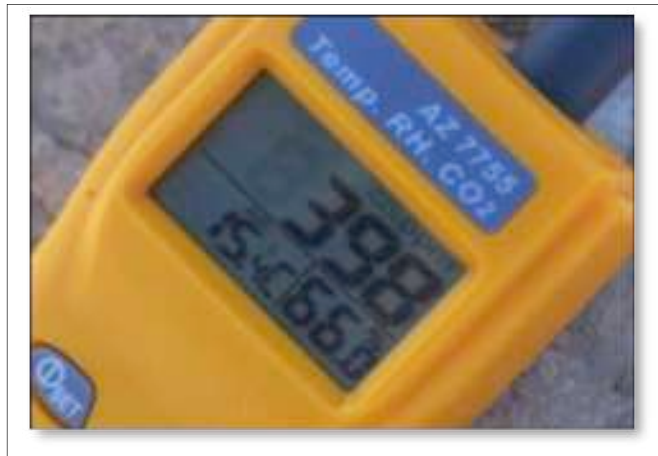
Equipment that measures three environmental factors of interest when performing in-situ tests: air temperature and humidity and CO₂ concentration level. (Figure 11)

Figure 11. Environmental Condition

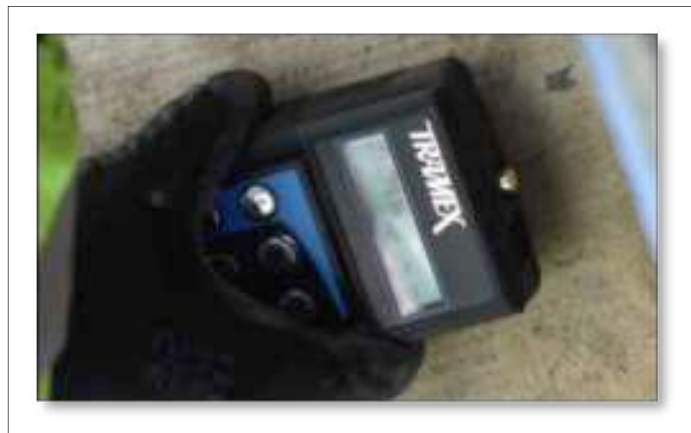
Equipment that, based on the measurement of electrical impedance, determines the moisture level of the concrete cover using eight contact points. It is required to validate the Air Permeability measurement according to the associated standards. (Figure 12)

Figure 12. Surface Moisture

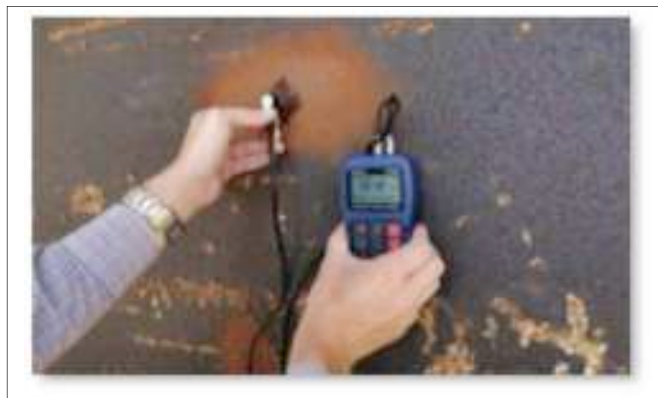
The ultrasonic equipment allows measuring the thickness of steel elements in an easy way. (Figure 13)

Figure 13. Steel Thickness

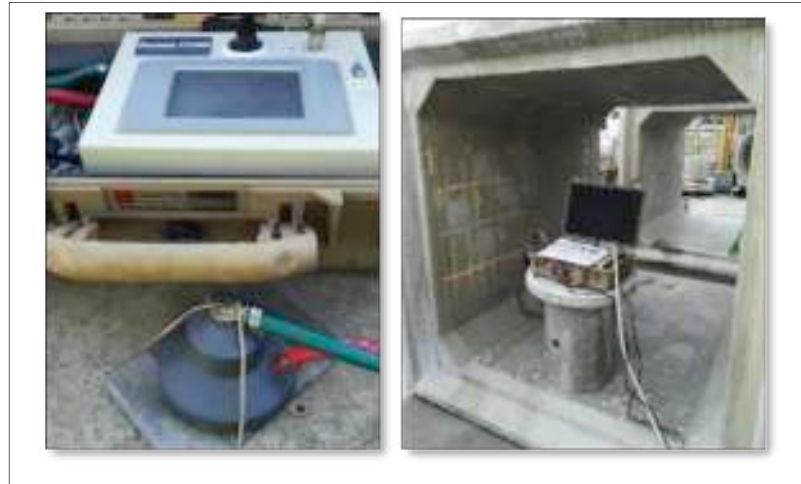
Through the creation of a vacuum on the concrete surface, this equipment measures the pressure increase occurring in a double chamber cell in a period of 6 minutes and according to the Swiss standard (Concrete Corrosion 261/1 Annex E, 2003). The rate at which this pressure increases due to the effect of atmospheric pressure is related to the permeability of the concrete cover. This methodology was developed for in-situ application and as a control of on-site concrete in terms of durability performance. It requires the measurement of batches composed of 6 measurement points. (Figure 14)

Figure 14. PermeaTorr Equipment - Air Permeability

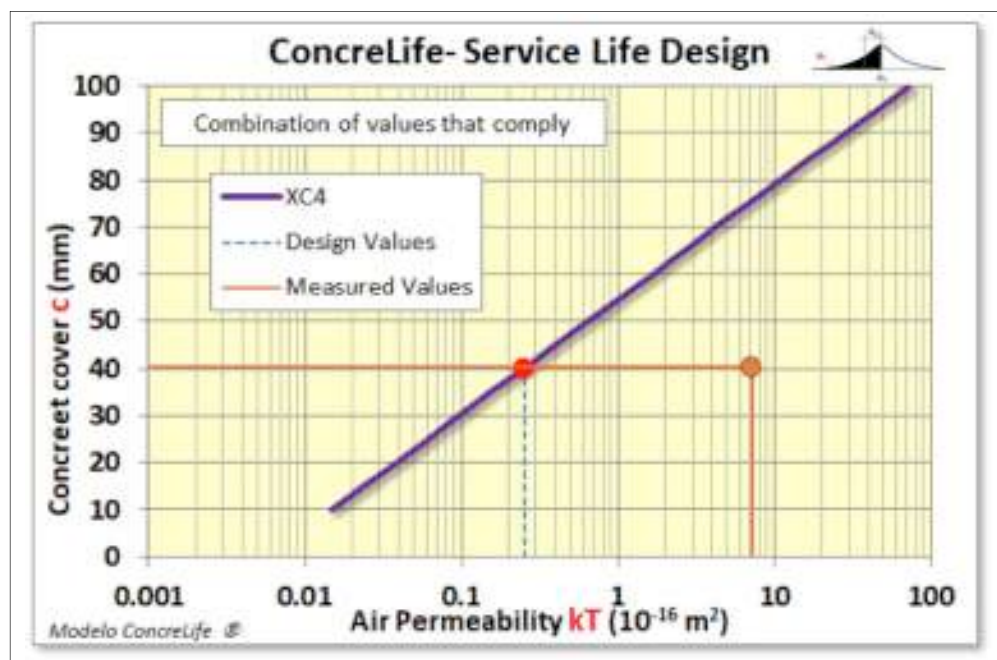
This Methodology has been included in the CTK-ConcreLife Model® (CTK, 2017). It allows the DESIGN of concrete for a particular Service Life, subject to different degrees of severity, either by the effect of chlorides or carbonation, and the subsequent CONTROL in the finished work. Figure 15 shows the relationship between Air Permeability and Cover Thickness obtained for a 50-year Service Life in a Carbonation environment condition. The red dot represents a defined thickness of $c=40\text{mm}$ and a Permeability $kT=0.25 \times 10^{-16} \text{m}^2$.

Figure 15. Relationship between Cover Thickness and Permeability for Class XC4 Environment

The area above the curve complies with the requirement of obtaining a Design Service Life of at least 50 years, a condition that is not met in this example when measuring in situ (orange dot with $c=40\text{mm}$ y $kT=7.20 \times 10^{-16} \text{m}^2$).

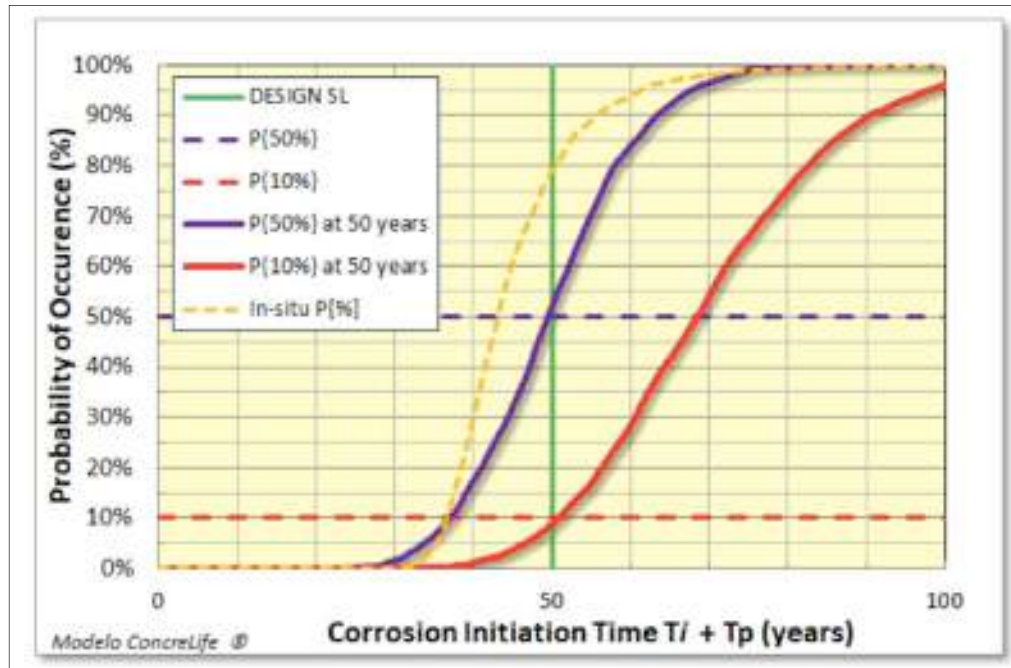
(Figure 16) shows the Probabilistic analysis of the same situation: the purple curve shows the DESIGN situation, corresponding to the red dot in Figure 16 with a 50% probability of corrosion initiation at 50 years (vertical green line). If it were desired that at this age, the probability of initiation would be only 10%, represented by the red curve, the Permeability value should be more demanding ($kT=0.14 \times 10^{-16} \text{m}^2$).

Finally, the dashed curve measured on-site as CONTROL indicates that at 50 years, the probability of corrosion initiation will be 77%. The 50% probability is expected at 43 years. If the measurement were performed at 10 years, the expected Residual Life would be 33 years.

Figure 16. Comparison between Corrosion Initiation Probability by Design and actual Conditions measured in situ

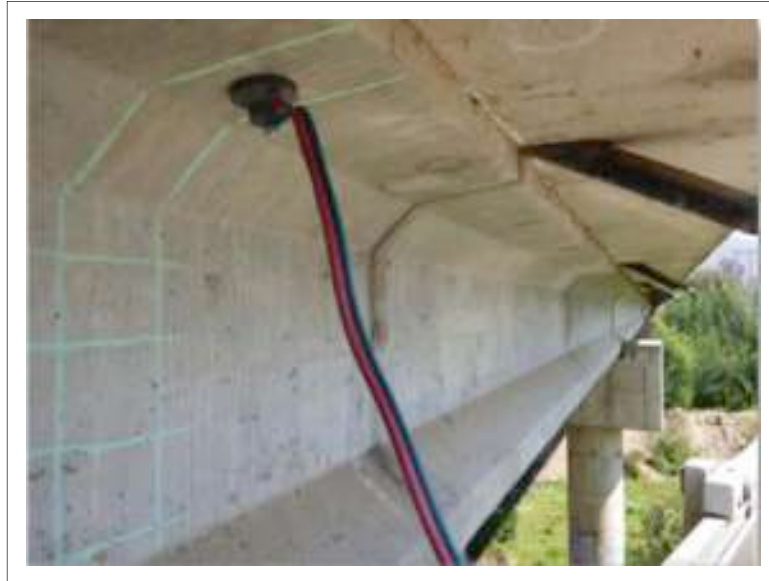
Figure 17. Air Permeability Measurement with PermeaTorr equipment on Prefabricated Beam Flange

The element under study, the upper pier built in situ, showed no signs of corrosion or cracks. Despite the dry environment, the low CO₂ content measured showed low carbonation rates, with a depth of only 2 mm and a Carbonation Rate of 0.6 mm/√year. The use of low-diameter bars was identified as a weak point. In case of corrosion, these bars would be quickly affected. The Corrosion Rate was < 10 μm/year. The strength determined through the Schmidt Hammer reached 36 MPa. The cover thickness is adequate, with 40 mm; although the permeability of the cover was high, with $kT=7.5 \times 10^{-16} \text{ m}^2$. This structure element is classified with an SGDL = 2.38 at Level III.

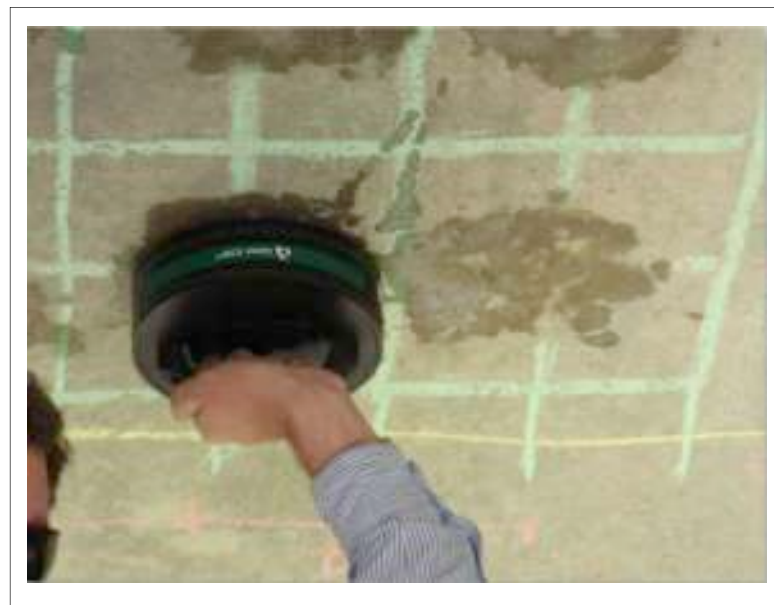
Figure 18. Corrosion Level Measurement with Icor equipment on the bottom surface of Prefabricated Slab

The element under study, the lower zone of roadways built in situ, showed corrosion signs. The corrosion rate was $72 \mu\text{m}/\text{year}$ (Figure 18). The CO_2 level measured in the environment showed high carbonation rates, with a depth of 29 mm and a Carbonation Rate of $3.9 \text{ mm}/\sqrt{\text{year}}$. As weak aspects, the use of low diameter bars was detected, which already showed a Corrosion Rate of $72 \mu\text{m}/\text{year}$. The strength determined through the Schmidt Hammer reached 28 MPa. The cover thickness is low, at 26 mm. This structure element is classified with an SGDL = 2.61 at Level I.
